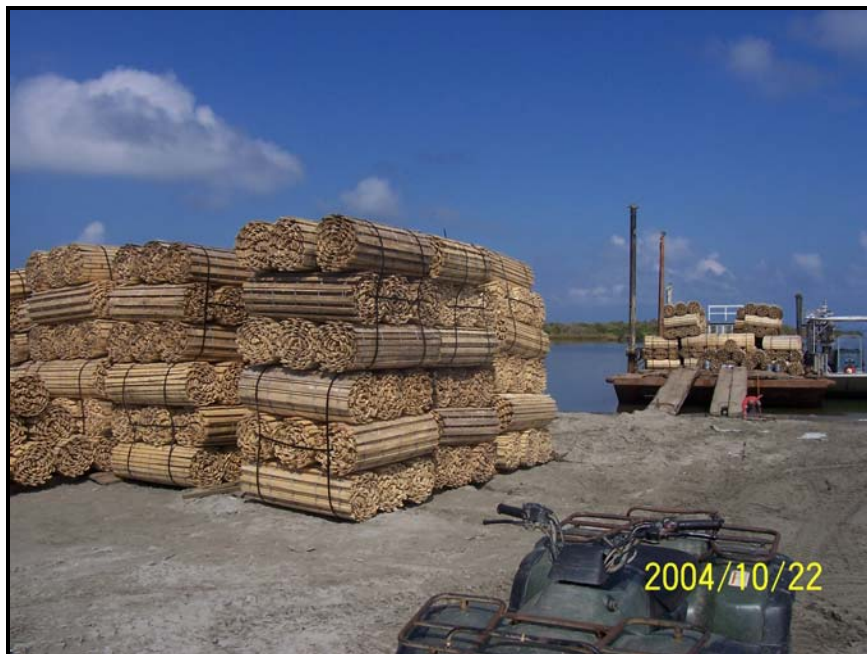
Photo 1. *View of sand fencing*

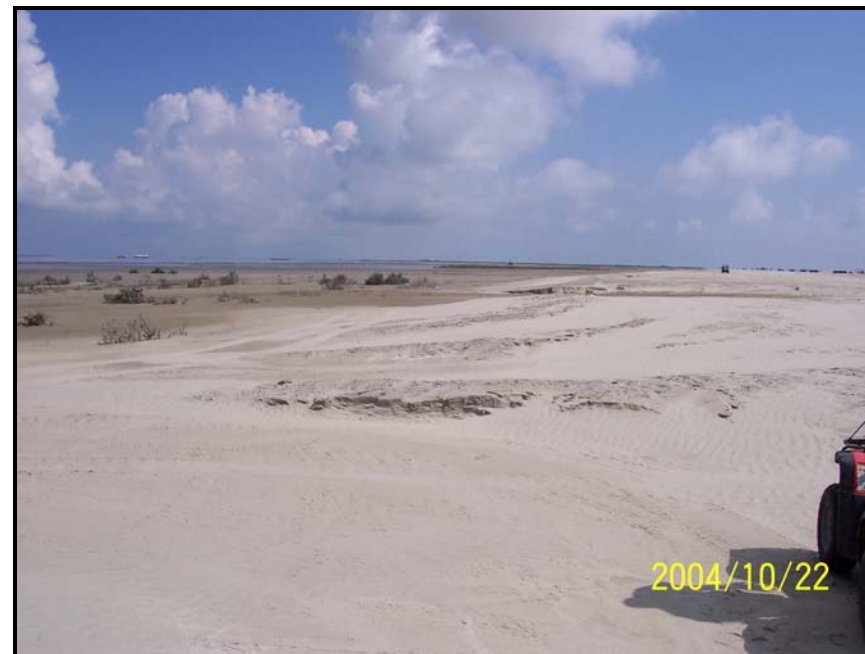
Photo 3. *Typical washout damage (back of dune platform) from TS Matthew, standing at Sta. 101+00 looking east*

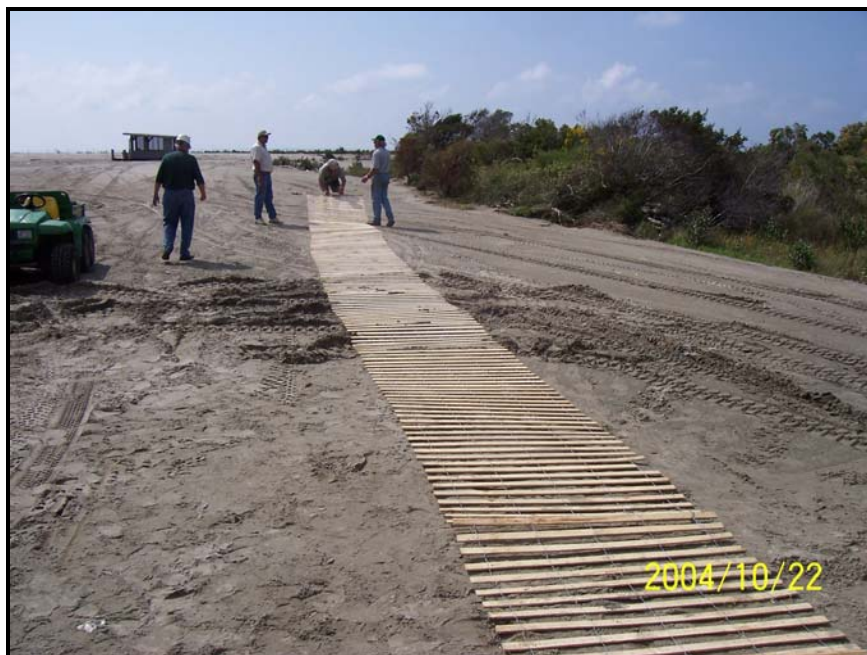
Photo 2. *View of sand fencing*

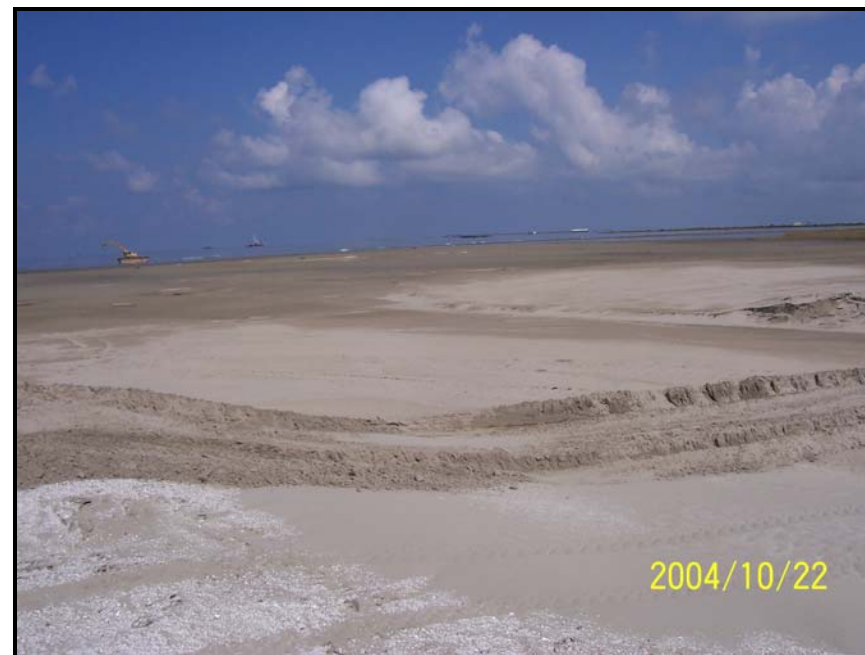
Photo 4. *Typical washout damage (back of dune platform) from TS Matthew, standing at Sta. 138+00 looking northeast*

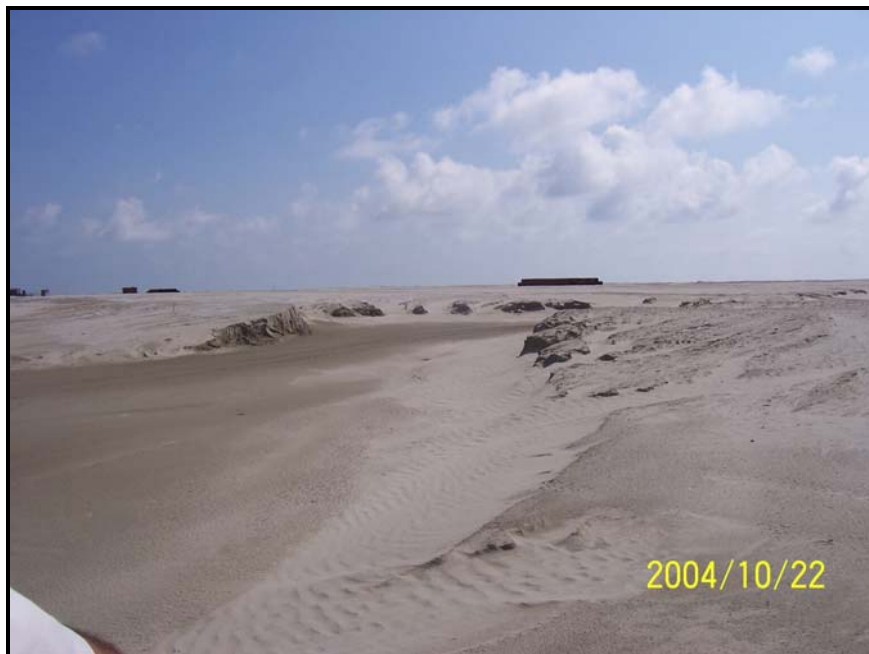
Photo 5. Typical washout damage (back of dune platform) from TS Matthew, standing at Sta. 150+00 looking southeast

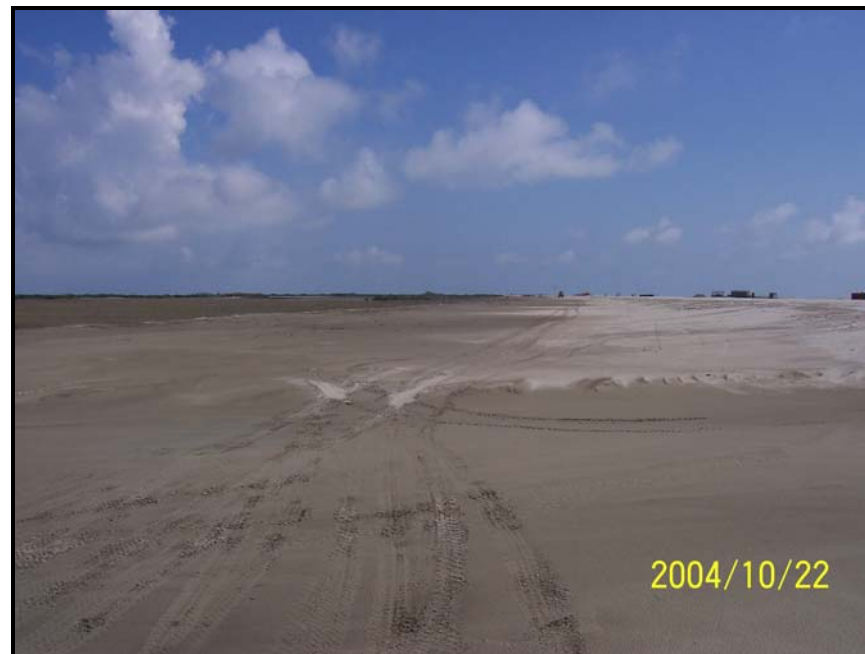
Photo 7. View of back of dune platform and back berm, standing at Sta. 150+00 looking east

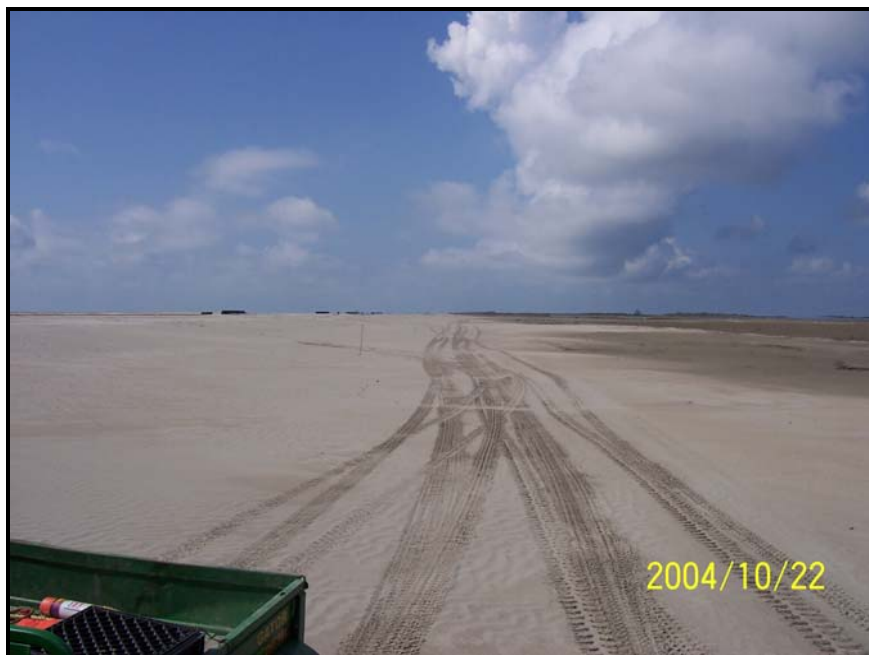
Photo 6. View of back of dune platform and back berm, standing at Sta. 150+00 looking west

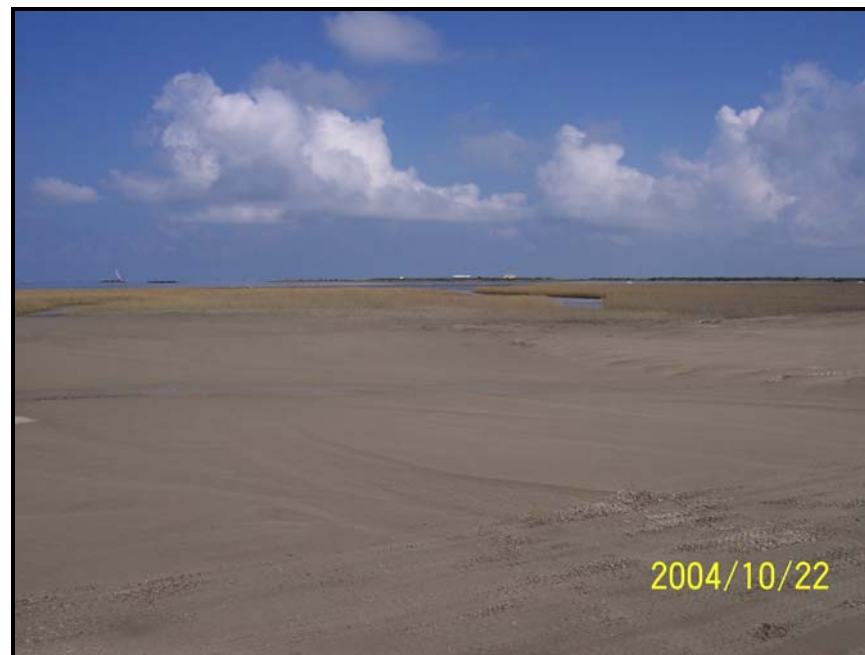
Photo 8. View of marsh platform at Sta. 150+00 looking northeast

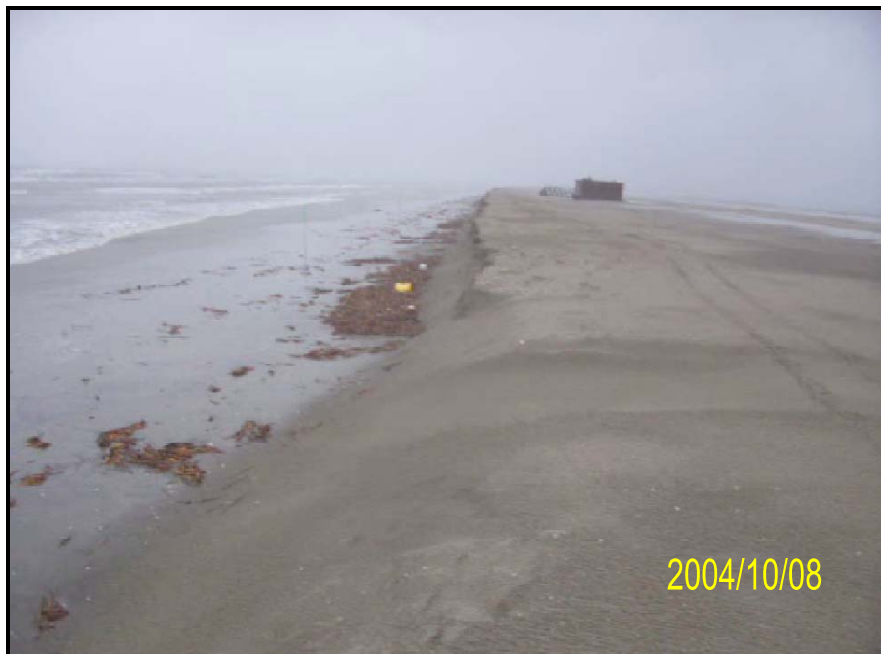
Photo 9. View of dune platform and beach at Sta. 166+00 (camp) looking west. Photo date: October 8, 2004 (as TS Matthew approaches)

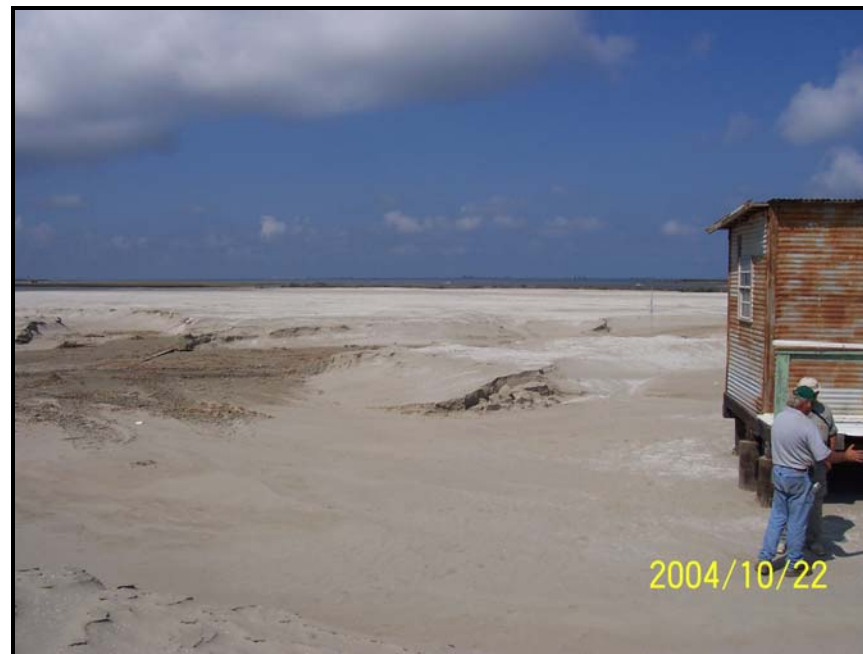
Photo 11. View of washout in dune platform from TS Matthew at Sta. 166+00 (camp) looking northwest

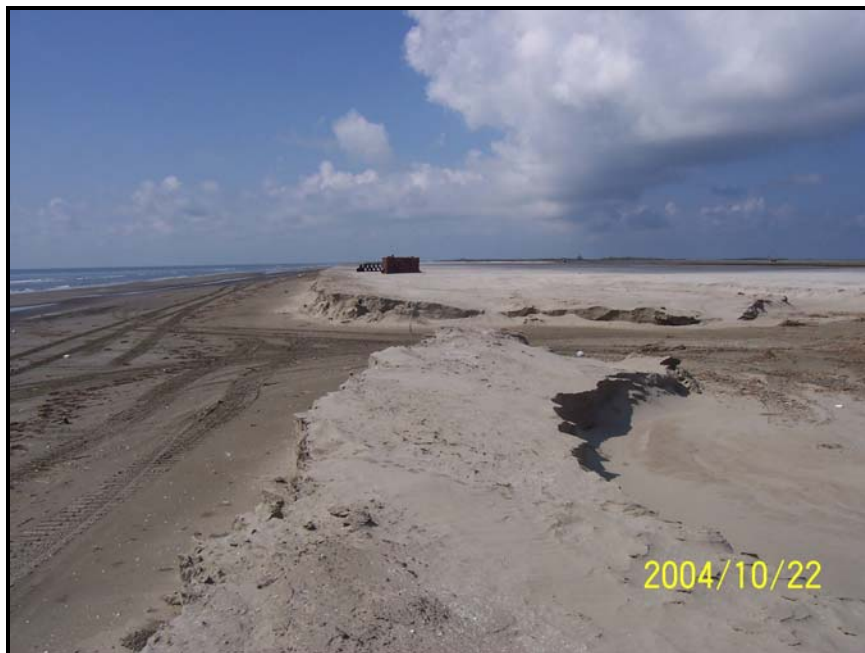
Photo 10. View of washout in dune platform from TS Matthew at Sta. 166+00 (camp) looking west

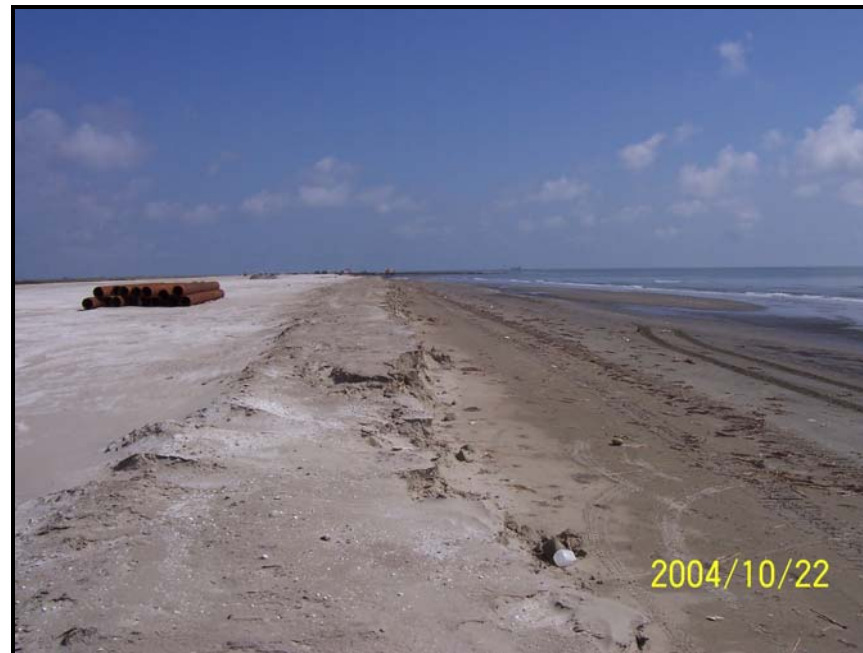
Photo 12. View of dune platform and beach, standing on top of dune at Sta. 166+00 looking east

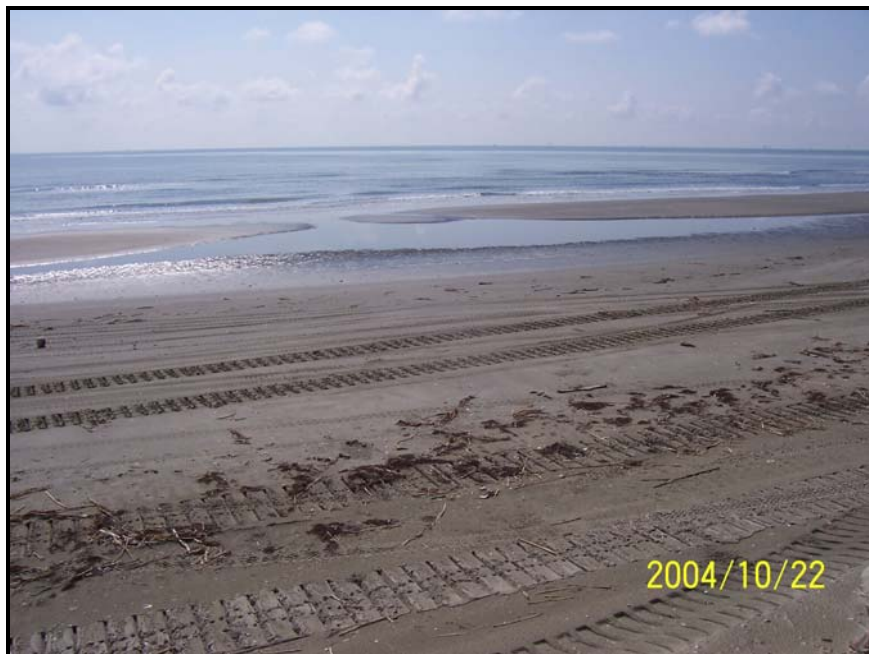
Photo 13. View of beach, standing on top of dune platform at Sta. 166+00 looking south (tide: appx. 1.0' NAVD)

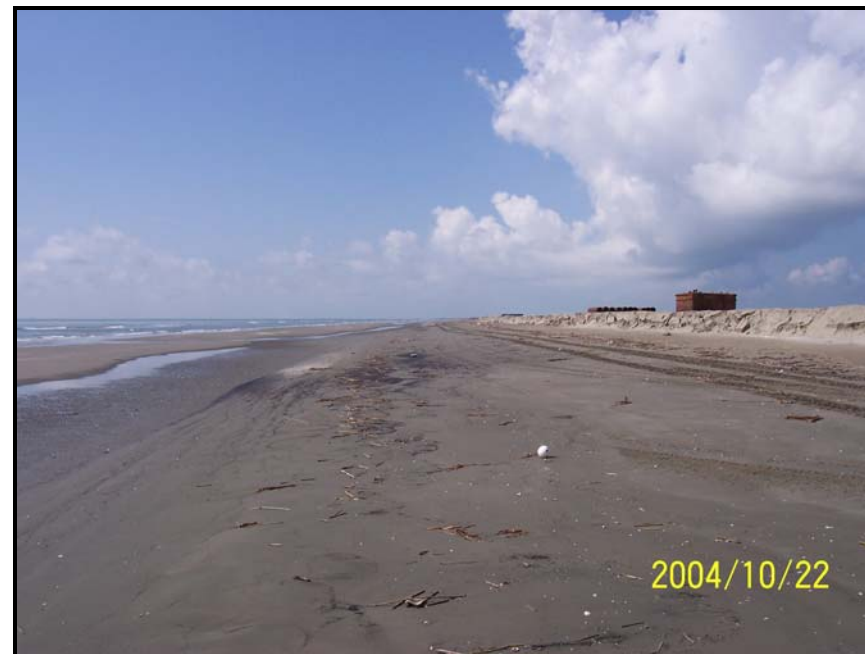
Photo 15. View of beach, standing at Sta. 165+50 looking west (tide: appx. 1.0' NAVD)

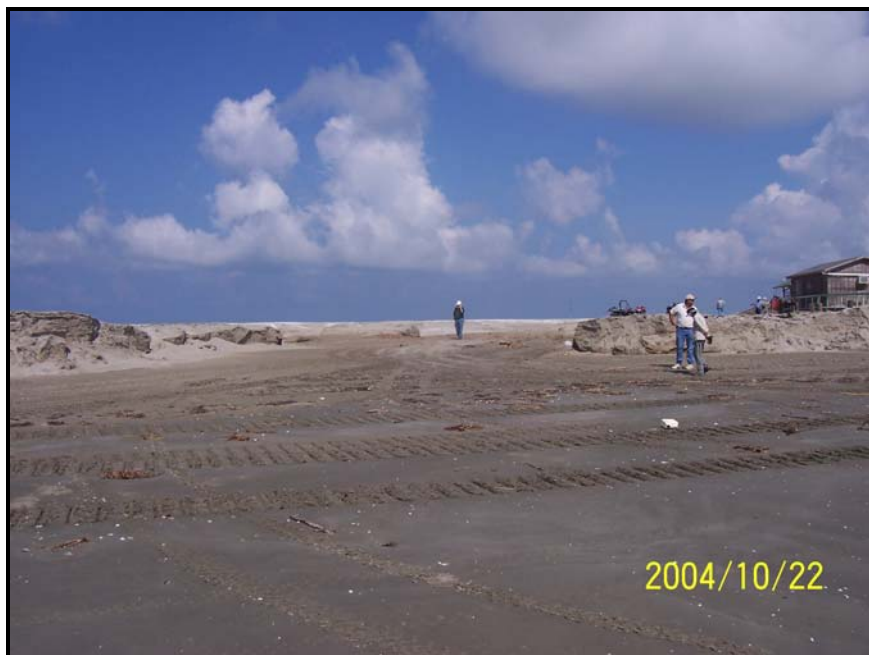
Photo 14. View of washout in dune platform from TS Matthew, standing on the beach at Sta. 165+50 looking north

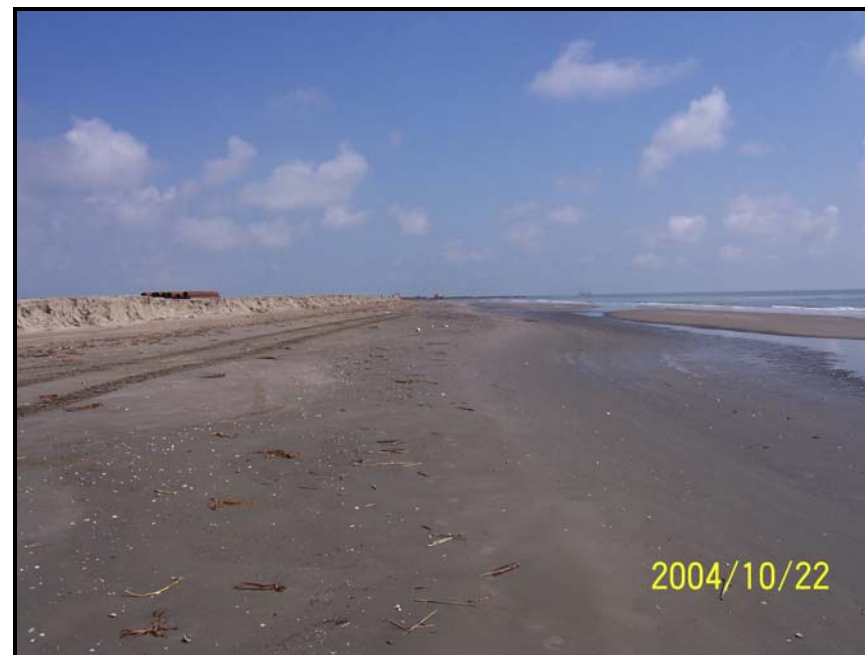
Photo 16. View of beach, standing at Sta. 165+50 looking east (tide: appx. 1.0' NAVD)

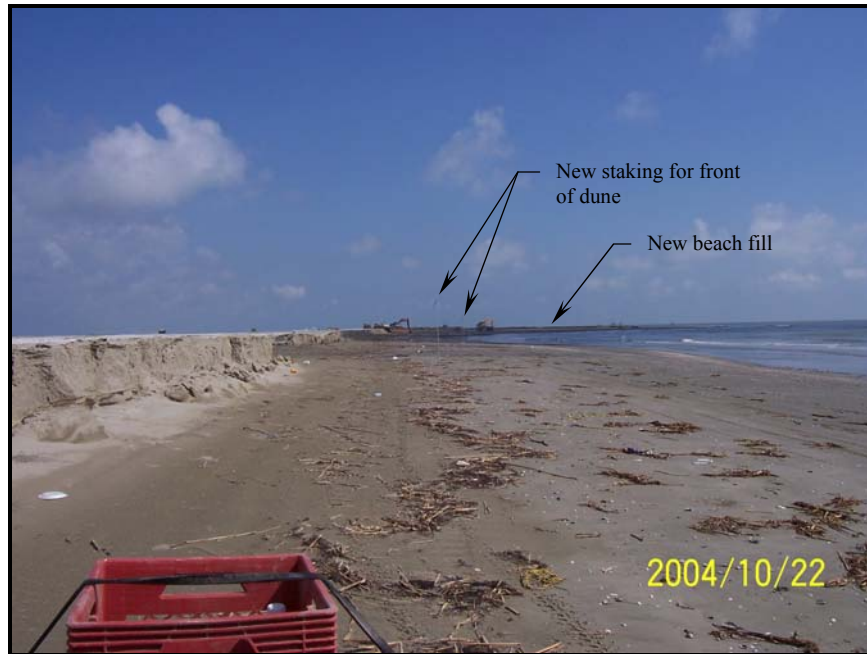
Photo 17. View of dune and beach erosion (foreground) and beach fill/dune repair operations (background), standing at Sta. 176+00 looking east

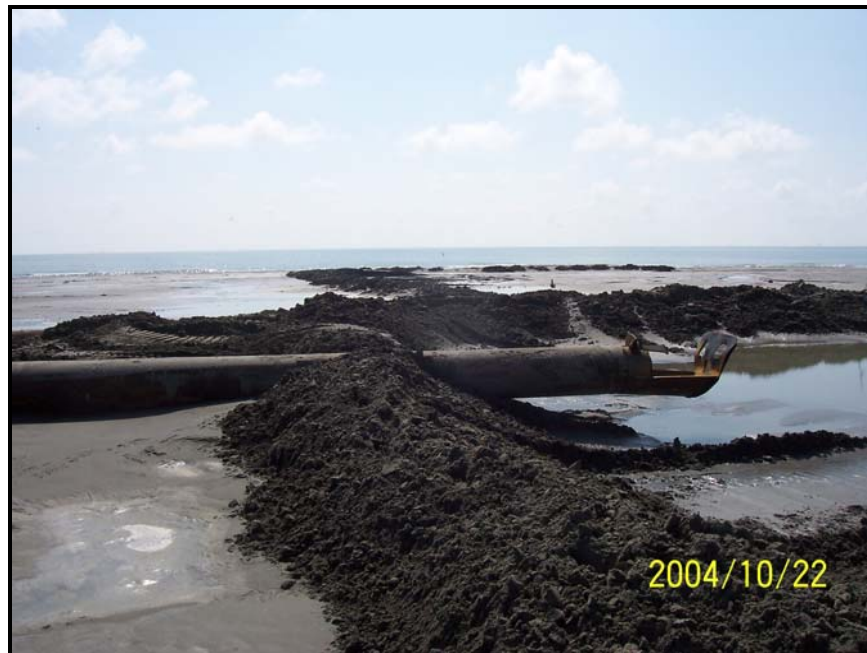
Photo 18. View of beach fill and discharge pipe at Sta. 191+50 looking south

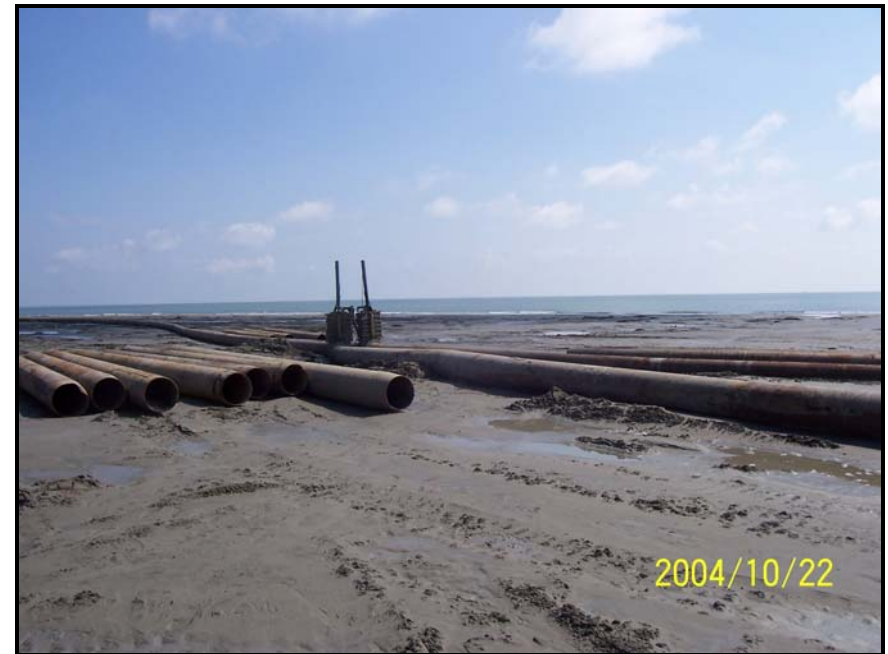
Photo 19. View of beach fill, discharge pipes, and y-valve used to split the dredge material flow (standing at Sta. 191+50 looking southeast)

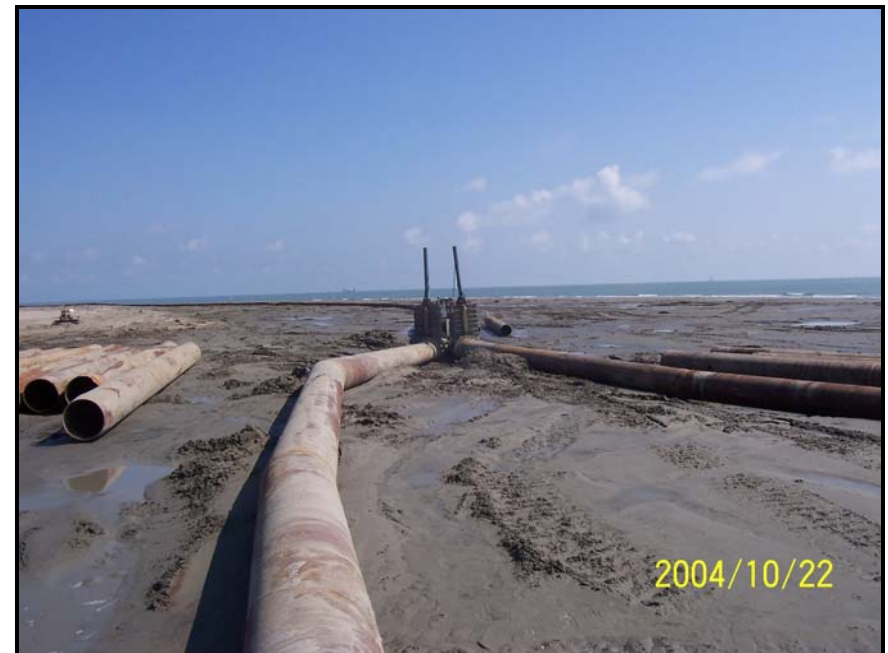
Photo 20. View of beach fill, discharge pipes, and y-valve used to split the dredge material flow (standing at Sta. 191+50 looking east)

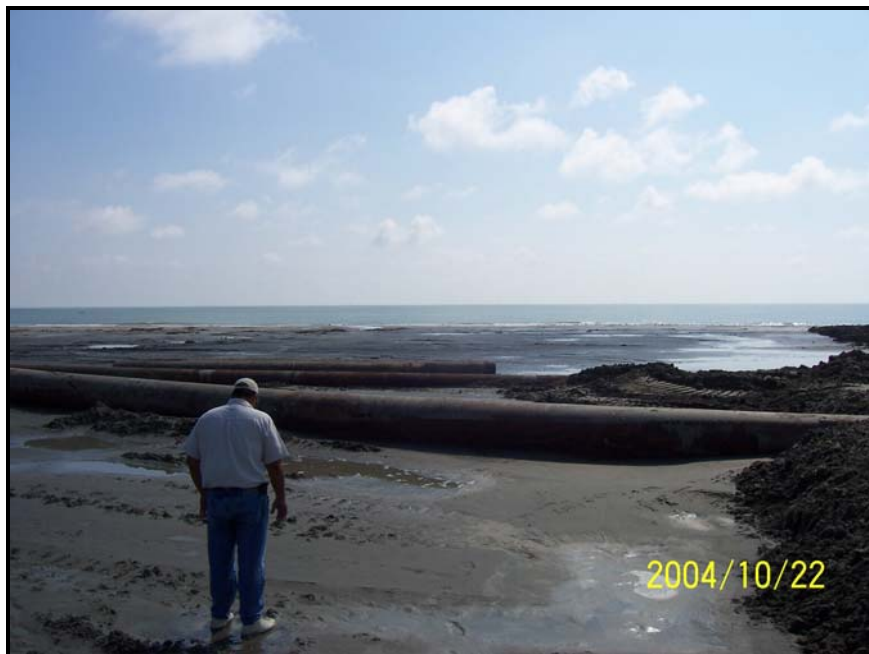
Photo 21. *View of beach fill and discharge pipes at Sta. 191+50 looking south*

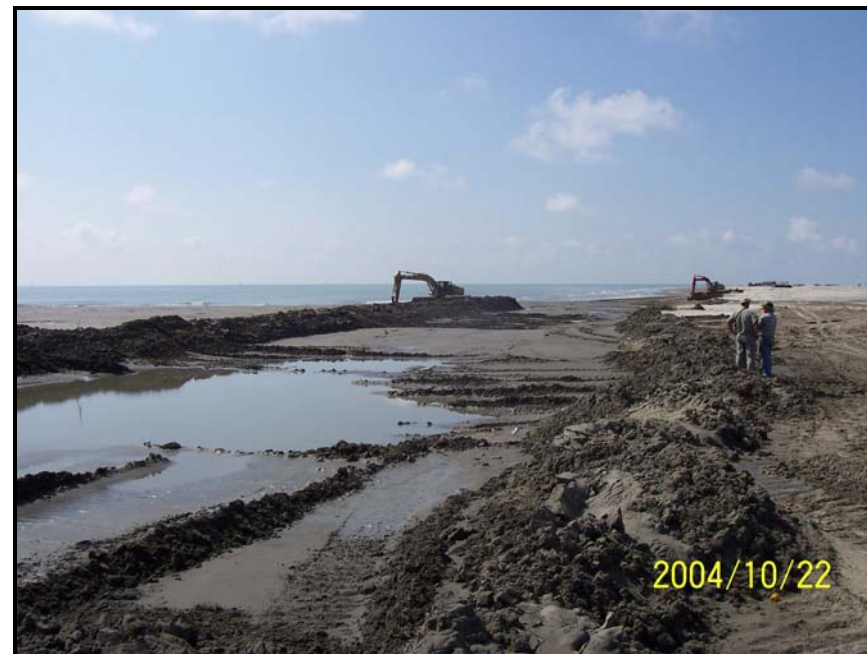
Photo 23. *View of beach fill and dike construction for dune repair at Sta. 191+50 looking southwest*

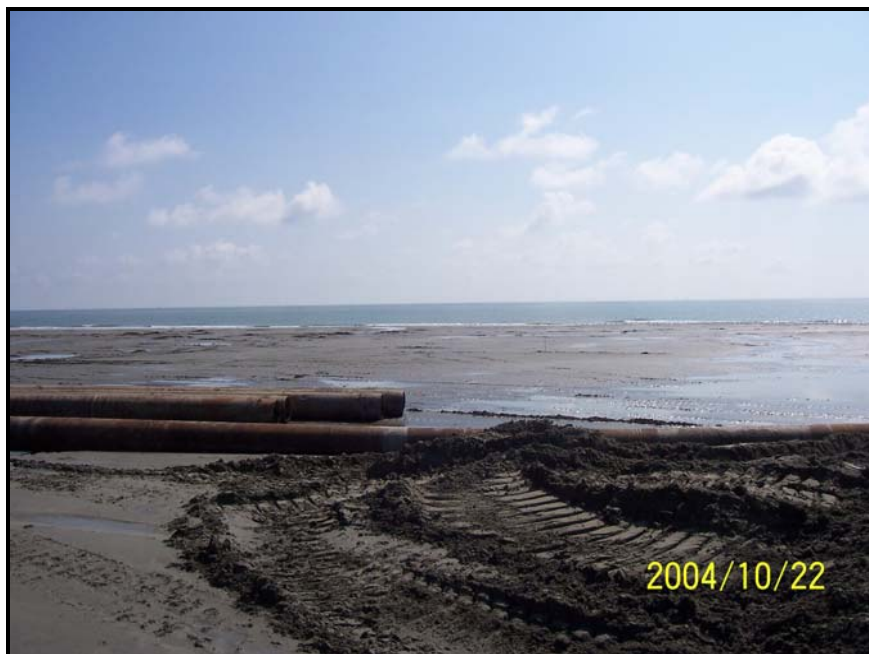
Photo 22. *View of beach fill and south discharge pipe, standing on north discharge pipe at Sta. 191+50 looking south*

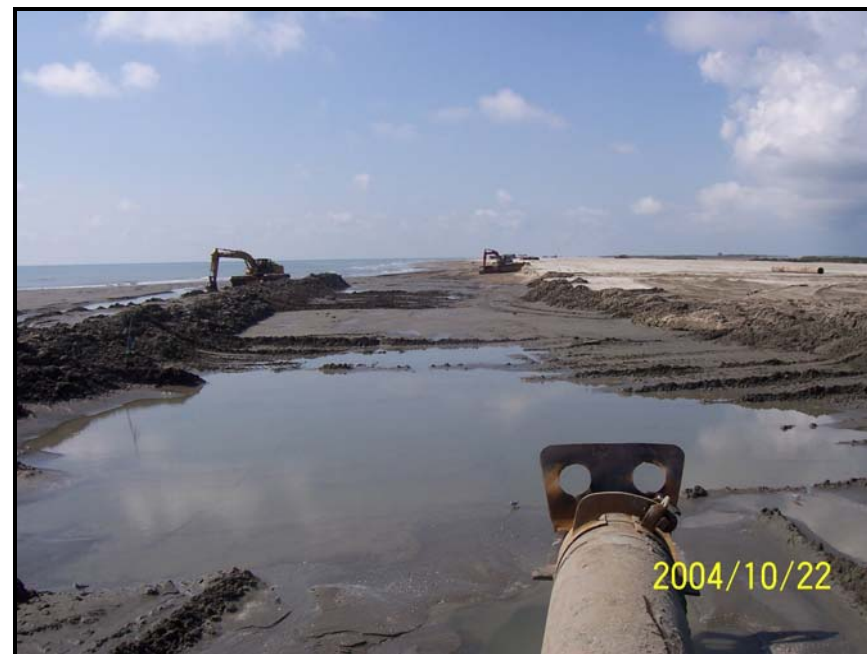
Photo 24. *View of beach fill and dike construction for dune repair, standing on north discharge pipe at Sta. 191+50 looking west*

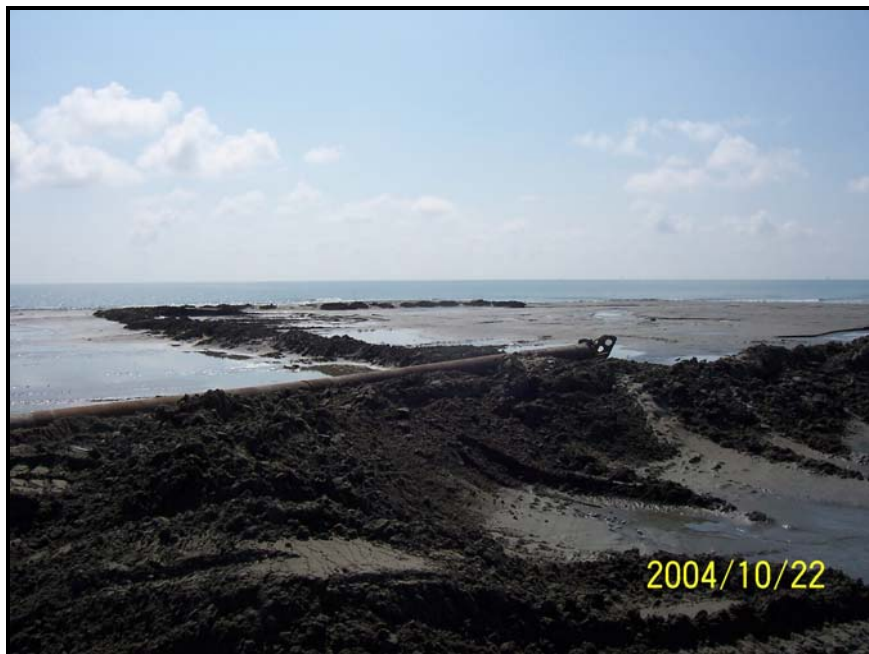
Photo 25. View of beach fill and south discharge pipe, standing on north discharge pipe at Sta. 191+50 looking south

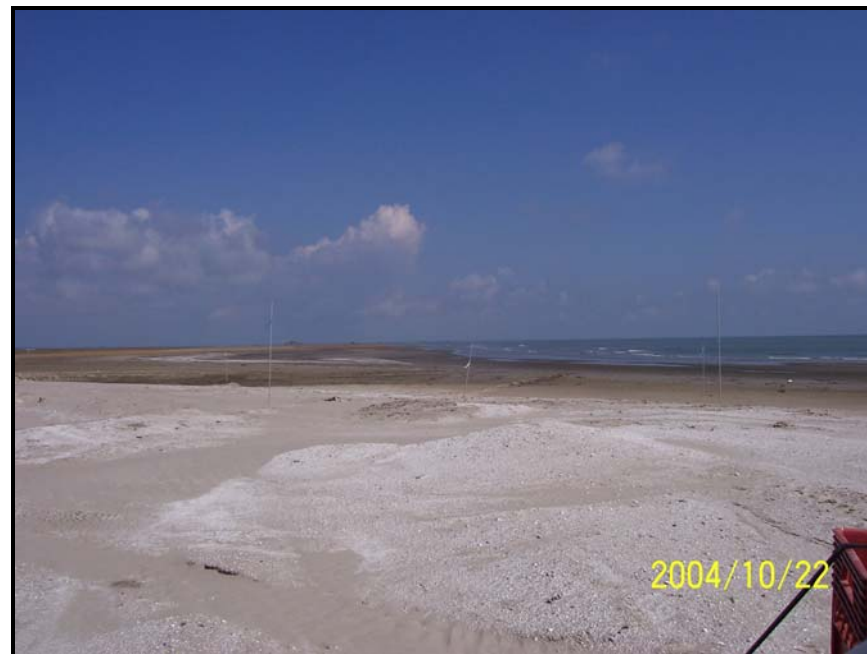
Photo 27. View of beach past the east end of the project, standing at Sta. 205+50 looking east

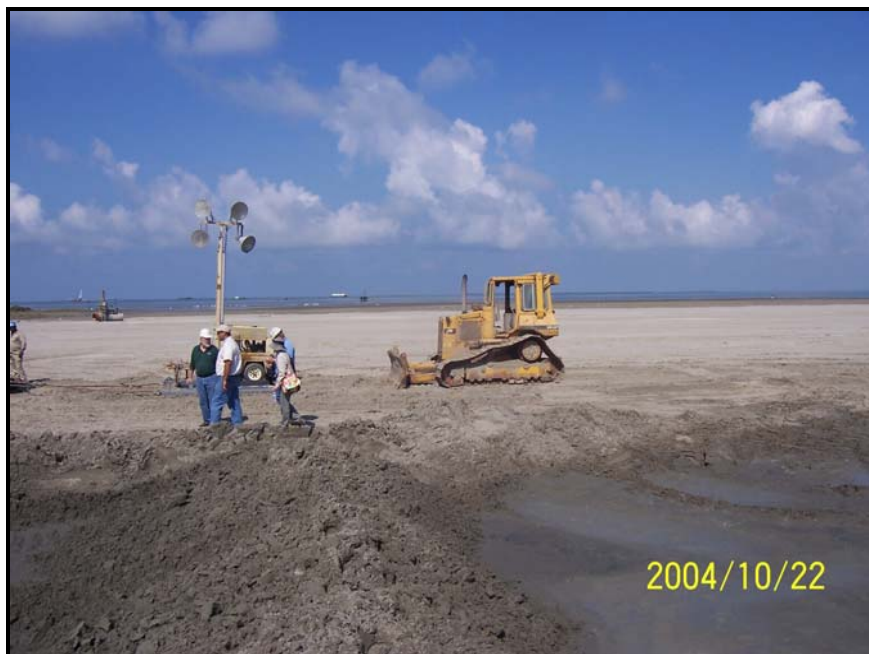
Photo 26. View of dune platform at Sta. 191+50 looking north

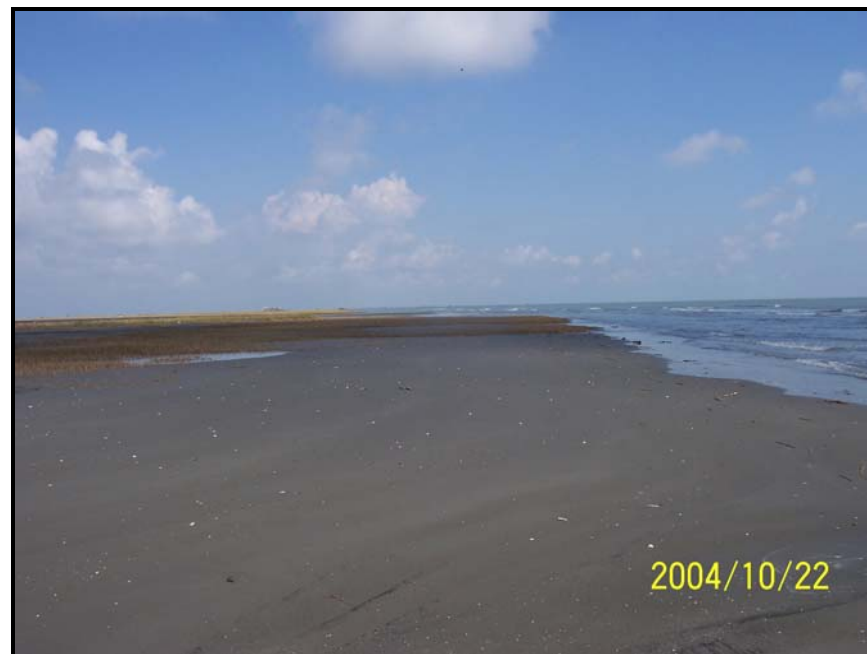
Photo 28. View of beach past the east end of the project, standing at Sta. 220+00 looking east
